Aruba Instant 6.5.4.27

This Aruba Instant release notes includes the following topics:

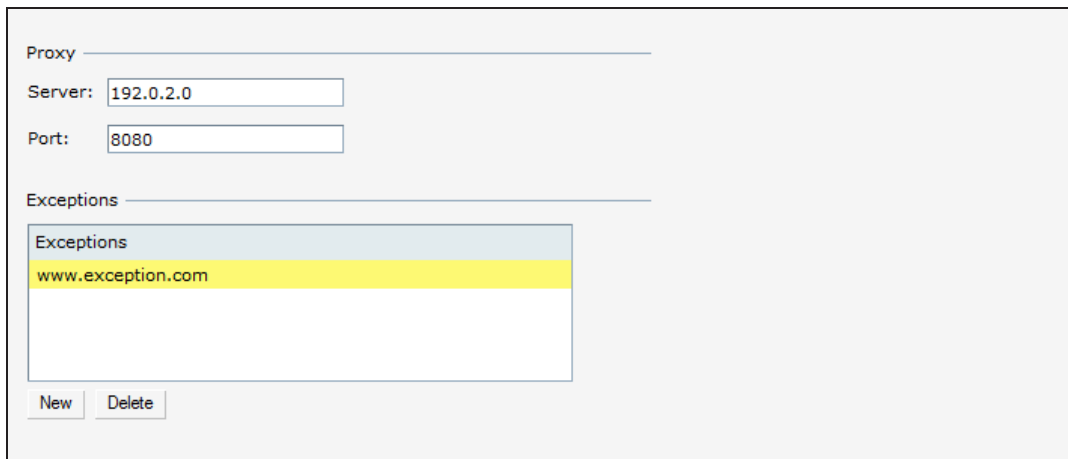
Figure 1 Proxy Configuration Window

The screenshot shows the Proxy Configuration Window. It has a 'Proxy' section with a 'Server' text box containing '192.0.2.0' and a 'Port' text box containing '8080'. Below this is an 'Exceptions' section with a list box containing 'www.exception.com'. At the bottom of the exceptions list are 'New' and 'Delete' buttons.

2. Enter the HTTP proxy server IP address in the **Server** text box.
3. Enter the port number in the **Port** text box.
4. If you do not want the HTTP proxy to be applied for a particular host, click **New** to enter that IP address or domain name of that host in the **Exceptions** section.
